Demonstration of Improved Technologies for Rehabilitating Metal Roofing in Severely Corrosive Environments

Final Report on Project F07-AR08

David M. Bailey, L.D. Stephenson, Ashok Kumar, Katharine Sweeton, Lawrence Clark, Michael W. Surratt, Karl Palutke, and Alan Meier March 2012

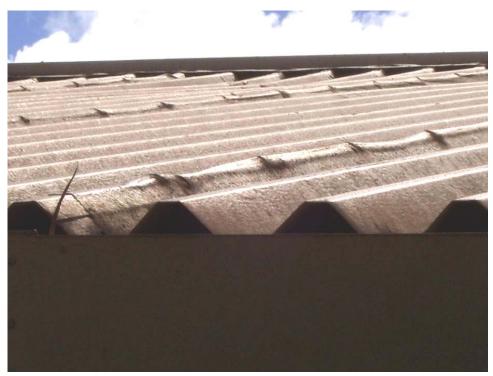
Building 118, a three-story troop barracks building, was selected for the technology demonstration. Its existing corrugated aluminum roof (Figure 2) is part of the original 1980 building construction and measures approximately 20,000 square feet. As the result of a 2005 real property condition assessment, the roof was determined to require replacement due to its age and recurring water leaks. The service order history for this roof indicated that only minor repairs were performed over the service life period, but an acrylic-based coating had been applied during this time. Defects noted were typically leaks around roof penetrations. In August 2005, the Wheeler AAF DPW submitted an Engineering Work Request for the Building 118 roof replacement action.

Figure 2. Existing roof on Building 118 prior to demonstration.

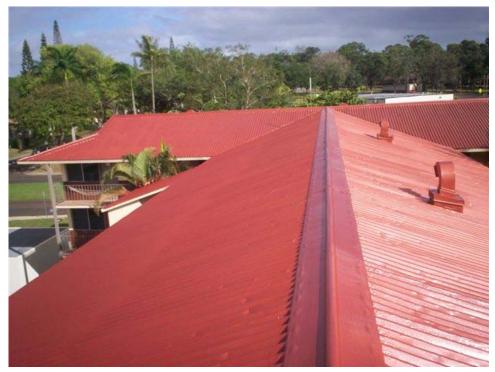
As noted in the previous chapter, there was initial concern about coating appearance because it was brighter than expected at the time of application. The coating consultant stated that the uneven sheen of the bright copper color would age to a darker copper color and within a few months would not be noticeable, and this turned out to be the case. The Wheeler DPW personnel subsequently expressed high satisfaction with the appearance of the pigmented polyurea-hybrid material.

Figure 8. Top view of Building 118 roof after completion. An uneven high gloss was visible from the ground

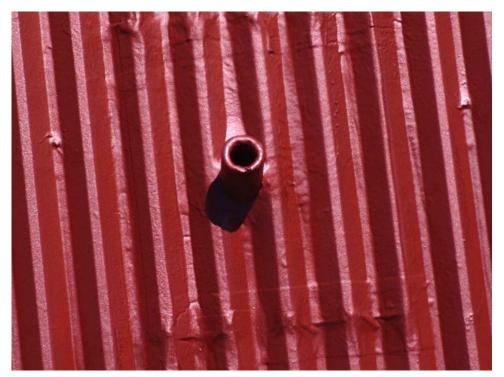
Figure 9. Finished appearance of vent stack. – Note the patch and thicker coating applied over the metal roof lap

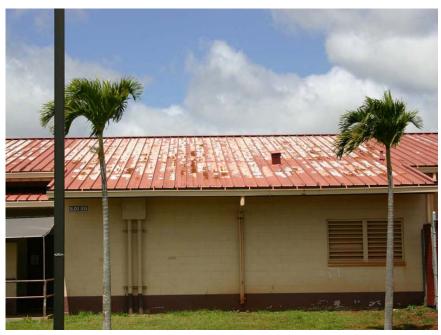
The failed roof on Building 835, which serves as a bowling center and snack bar, is part of the original 1985 building construction. Its standing-seam metal roof was displaying severe paint deterioration/flaking (Figure 10) and some corrosion, but it remained structurally sound. There was evidence that the roof had been repainted but the coating did not properly adhere to the substrate. As a result, the recoating material recently starting to peel off in large sheets. According to the Wheeler AAF DPW Facility Manager, the roof and entire building exterior was scheduled for repainting. Typically, when repainting, the new coating is not expected to have the same service life as a factory-applied baked-on finish. And in this case, because of severity of coating failure and corrosion, the surface would have required extensive surface preparation; making it an excellent candidate for re-cover.

Figure 10. Roof of Building 835 before re-cover. Paint was peeling off in large sheets.

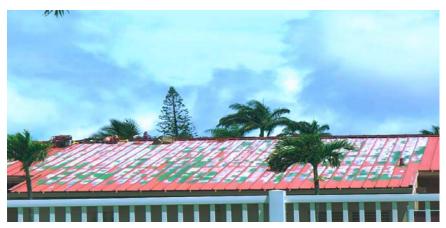
remove rust, which was necessary due to the advanced deterioration of the finish and significant amount of corrosion that existed. After the pressure washing, all of the corroded areas on the upper roof were treated using a rust-inhibiting coating (see Figure 12 and Annex 2, Appendix 2E).

Figure 11. Pressure washed and rust-treated roof areas.

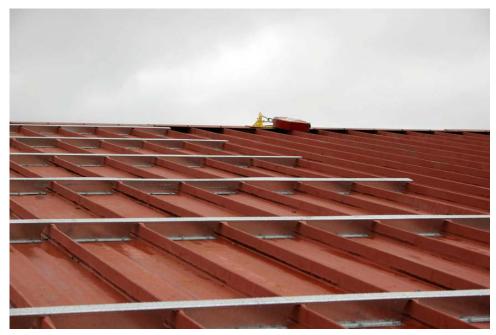
Figure 13. Installed custom manufactured sub-purlin system designed to bridge underlying metal roof panel ribs..

Next, the crew removed and disposed of the old gutter and fascia. Due to the adjustment for a raised profile of the new roof and a change in the new fascia and gutter detail, approximately 2 in. of the existing roof had to be trimmed back. The sub-purlins were then installed (see Figure 13) over the entire upper roof section following the manufacturer's guidelines. They were attached to the existing underlying purlins using self-tapping, corrosion-resistant fasteners. As this was being done, the installation of the new fascia and gutters began (see Figure 14). These operations were done simultaneously as the fascia and gutter installation had to be complete before the new upper roof could be installed.

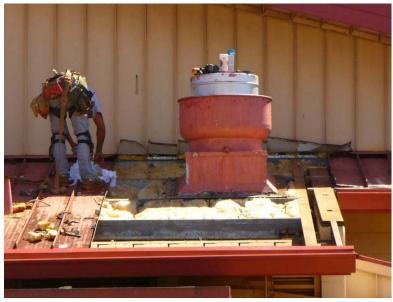
The lower roof sections, which were smaller in area, were not addressed until the upper main roof was completed because they required complete demolition to remove the old roofing. Removal was necessary due to the limited clearance from the roof above and the numerous curbs that would have required additional structural support if raised to the required height. The installation process was the same as for the main upper roof except that the new panels were installed directly to the original purlins that once supported the original roof panels. Large vents and curbs were located on these sections, requiring significant effort and workmanship to install properly (Figure 21).

Figure 21. Demolition of lower roof above kitchen area.

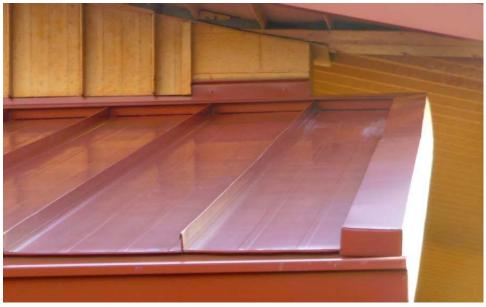
Figure 22. Finished edge detail and wall flashing. (Note that there are no exposed fasteners in these cleated eave details.)

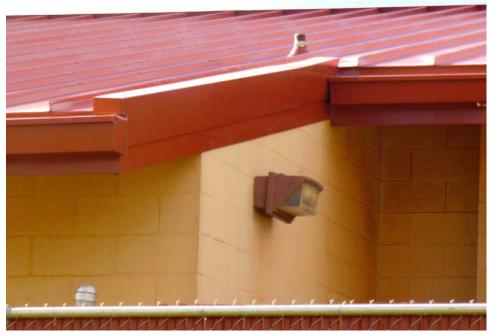
Figure 23. Finished detail work of fascia and gutter.

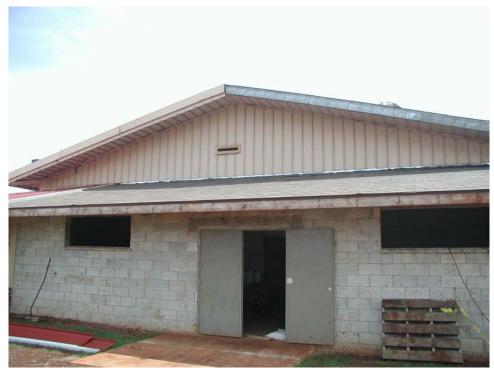
Before work began it was discovered that an addition had been constructed on the south end of the building after the project contract was awarded. The addition had an asphalt shingle roof over a plywood deck and wood fascia, so the scope of work had to be revised to include removal of the shingles and sheathing and addition of a new SSSMR with new metal fascia and soffit (Figure 24 and Figure 25). The two roof planes were not in alignment, so an expansion joint with a batten cap was used to tie the two roofs together.

Figure 24. Building addition with asphalt shingles prior to metal roof installation.

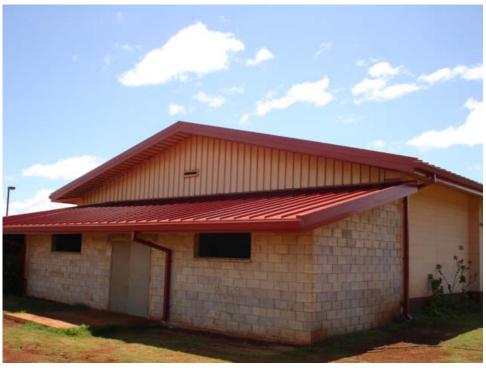
Figure 25. Building addition with finished standing seam roof.

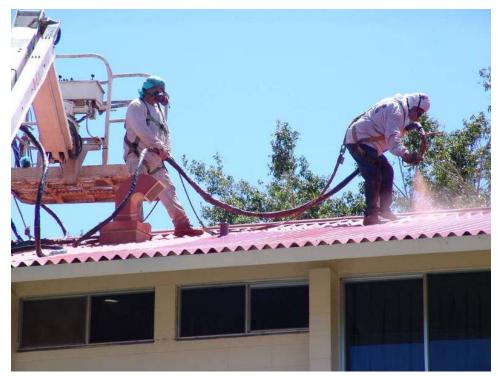
The quick setting of the material did not allow overspray to blend into newly sprayed areas. In many cases the amount of overspray detected was attributable to the standoff distance of the spray gun to the surface, the angle of impact of the sprayed material, wind gusts, the proportioner's back pressure, and spray tip selection. Figure 27 illustrates the overspray observed during this project. As seen in Figure 28, the polyurea-hybrid overspray droplets do not flash or coalesce, and they cure almost immediately upon contact. Overspray was visible as dull areas on shiny surfaces, creating a "halo effect." The following observations about overspray were noted during the application process:

Figure 27. Topcoat being applied with overspray evident.

- Normally the applicator will position the spray gun 2.0–2.5 ft from the surface being coated. If the applicator raises the spray gun any higher, the potential for overspray increases.
- The applicator should apply the coating at a 90-degree angle to the surface to minimize overspray. The team noted that when the applicator flexed his wrist side-to side or when he extended his arm out at an angle to reach the edges of the roof, overspray occurred. Also, as noted during the applicator training, higher spraying pressure and higher material temperature will produce more overspray.

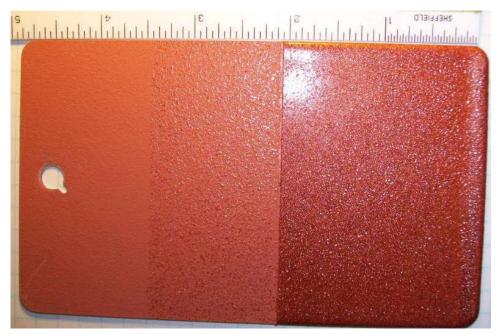
Figure 28. Example of appearance of topcoat overspray on a test coupon.

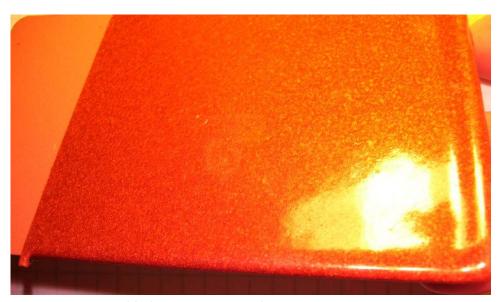
Figure 29. Gloss appearance of topcoating on test coupon.

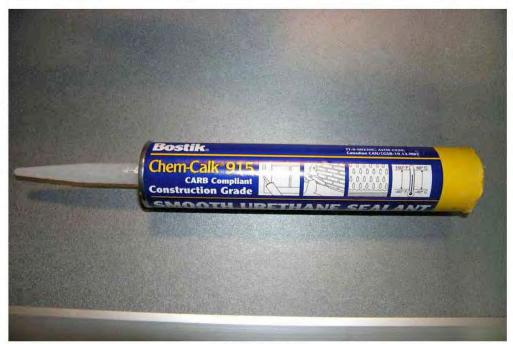
PHOTOGRAPH 1
CAULK USED BETWEEN ROOF PANELS

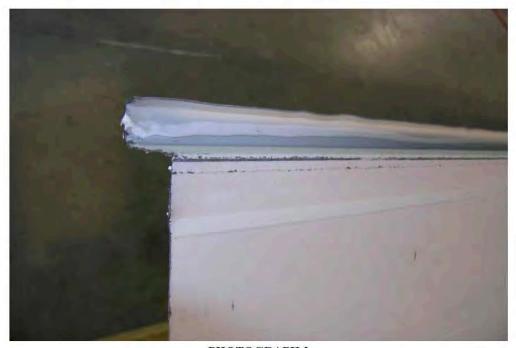
PHOTOGRAPH 2 CAULK APPLICATION

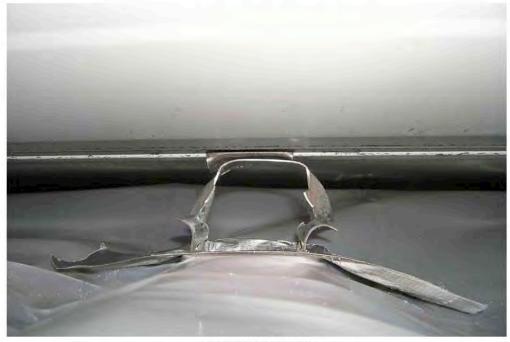
PHOTOGRAPH 12 EXPANSION CLIP FAILURE

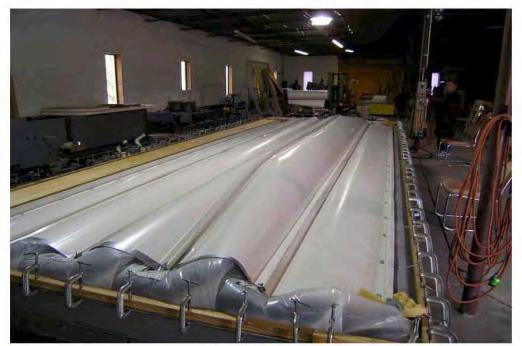
PHOTOGRAPH 19 FIXED CLIP FAILURE

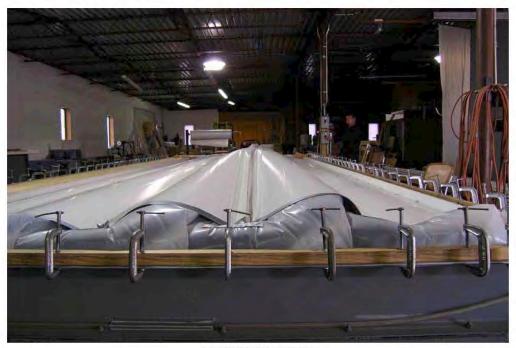
PHOTOGRAPH 20 FIXED CLIP FAILURE

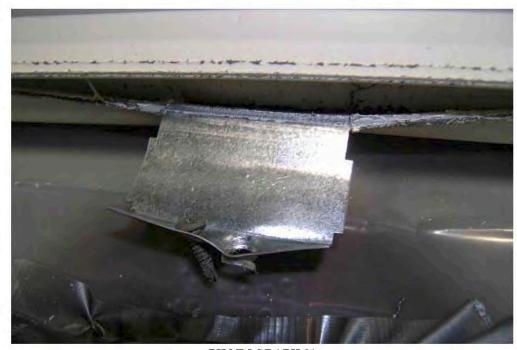
PHOTOGRAPH 21 FIXED CLIP FAILURE - 1,2

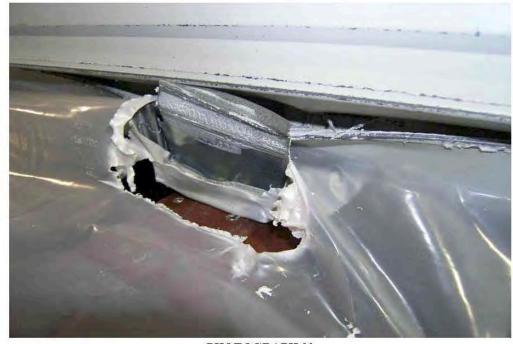
PHOTOGRAPH 22 FIXED CLIP FAILURE - 3

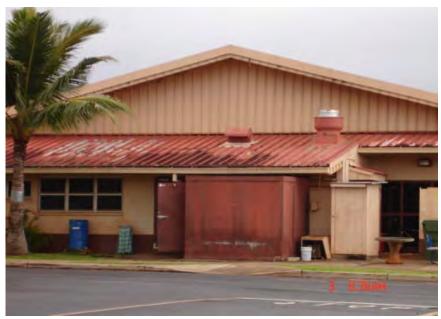
ROOF BEFORE - 03 AUG 08

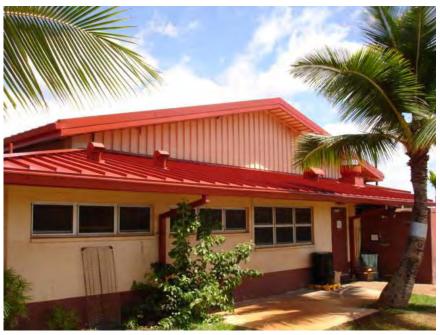
ROOF AFTER - 17 SEPT 08

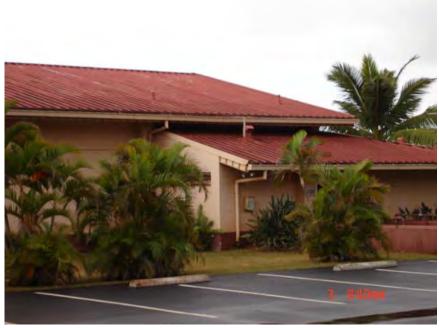
Roof Before - 03 Aug 08

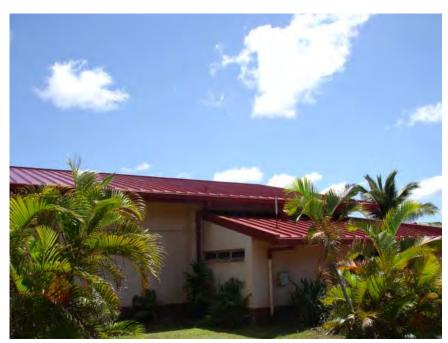
ROOF AFTER - 17 SEPT 08

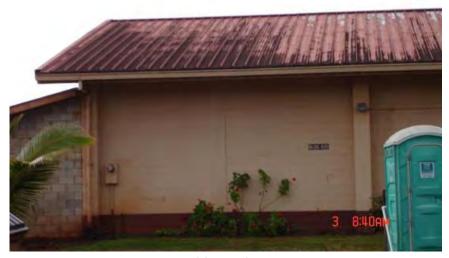
ROOF BEFORE

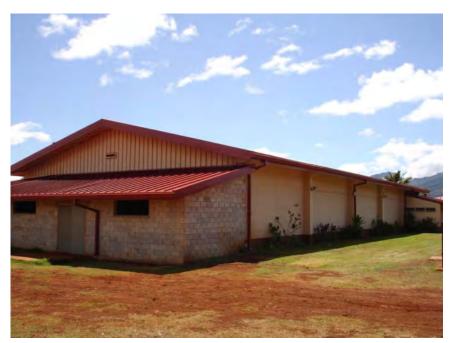
ROOF AFTER - 17 SEPT 08

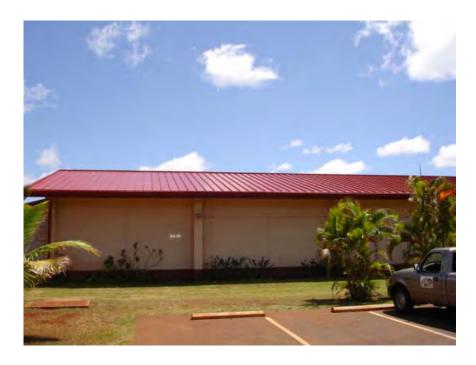
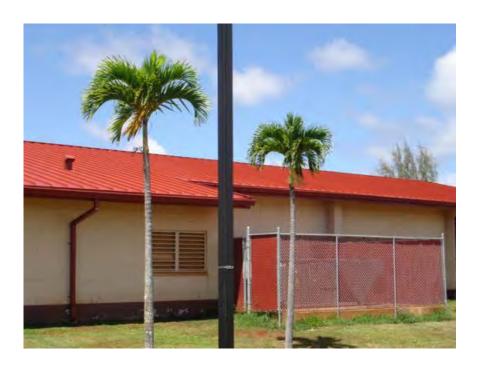
Troop self-help interface: detail, storage add-on, back side.
